## Case History: Atchafalya Run

### CETCO Oilfield Services Process for Treating Pipeline Hydrostatic Test Water during Pigging Operations

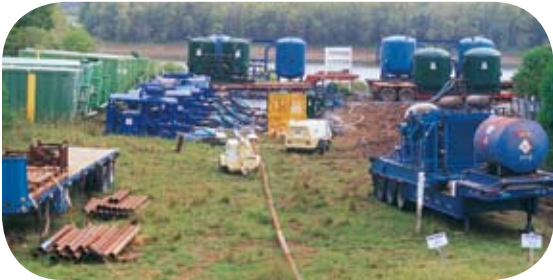
Equipment Layout (above) Water Polishing Vessels (below)

CETCO Oilfield Services supplied the personnel and equipment capable of handling such a large-scale project. CETCO Oilfield Services achieved water treatment rates of over 20 barrels per minute. The entire project was completed successfully, with CETCO Oilfield Services treating and discharging 68,200 barrels of water into the river.
