Case History: Clean Lines Make Fast Runs

CETCO Oilfield Services Provides Pipeline Cleaning Prior to Inspection Tool Runs

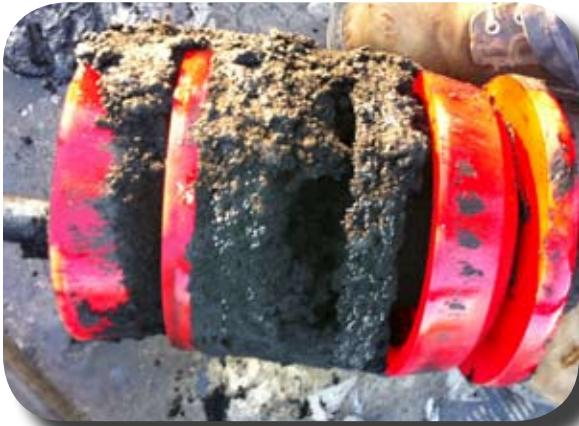
Brush Pig with Debris

CETCO used a combination of chemical injection and mechanical pigging to remove the buildup. CETCO provided product stream separation into two phases, removing the water and debris phase and depositing it in a 300-barrel tank. CETCO removed residual emissions through our smokeless flare stack where they were safely burned off. Any remaining contaminants were filtered using filter separators and then sales quality product was returned to the pipeline.

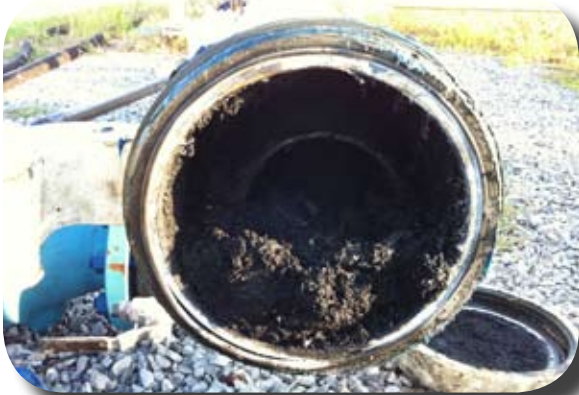
Pig Trap with Debris

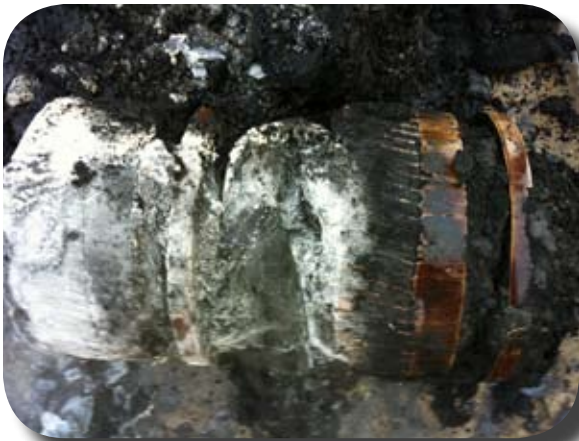
Dozer Pig with Debris
