Case History: Minnesota Makeover

Minnesota: Treating Hydrostatic Test Water

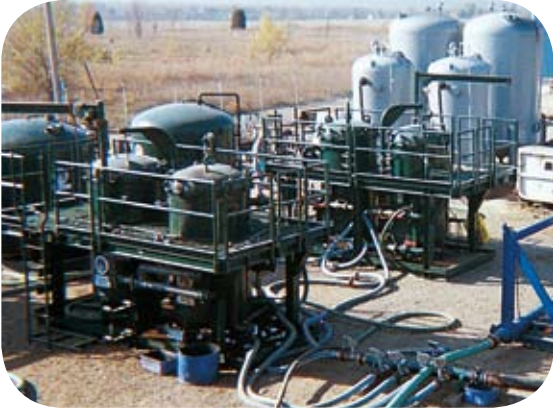
Equipment Layout

Fluid was pumped from the pipeline into three storage tanks located at the pipeline's tank farm. Fluid was then pumped from the storage tanks directly to CETCO Oilfield Services onsite equipment. On average, CETCO Oilfield Services treated the fluid at a rate of 10 to 15 barrels per minute. Rates as high as 20 barrels per minute were achieved. CETCO Oilfield Services process discharged about 15,000 barrels of clean water per day.

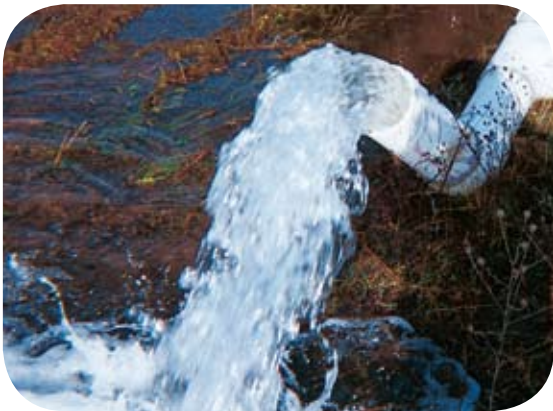
Clean Water Discharge Point

The project was completed in 30 days, with CETCO Oilfield Services treating and discharging 320,000 barrels of water. CETCO Oilfield Services personnel continuously monitored the clean water by using an onsite laboratory to ensure all discharge criteria were met.
